Loma Prieta Earthquake October 17, 1989

PRELIMINARY
RECONNAISSANCE REPORT

This report was sponsored by
the Earthquake Engineering Research Institute
and the Committee on Natural Disasters
of the National Research Council's
Commission on Engineering and Technical Systems,
with support from
the National Science Foundation
November 1989

Earthquake Engineering
Research Institute
89-03

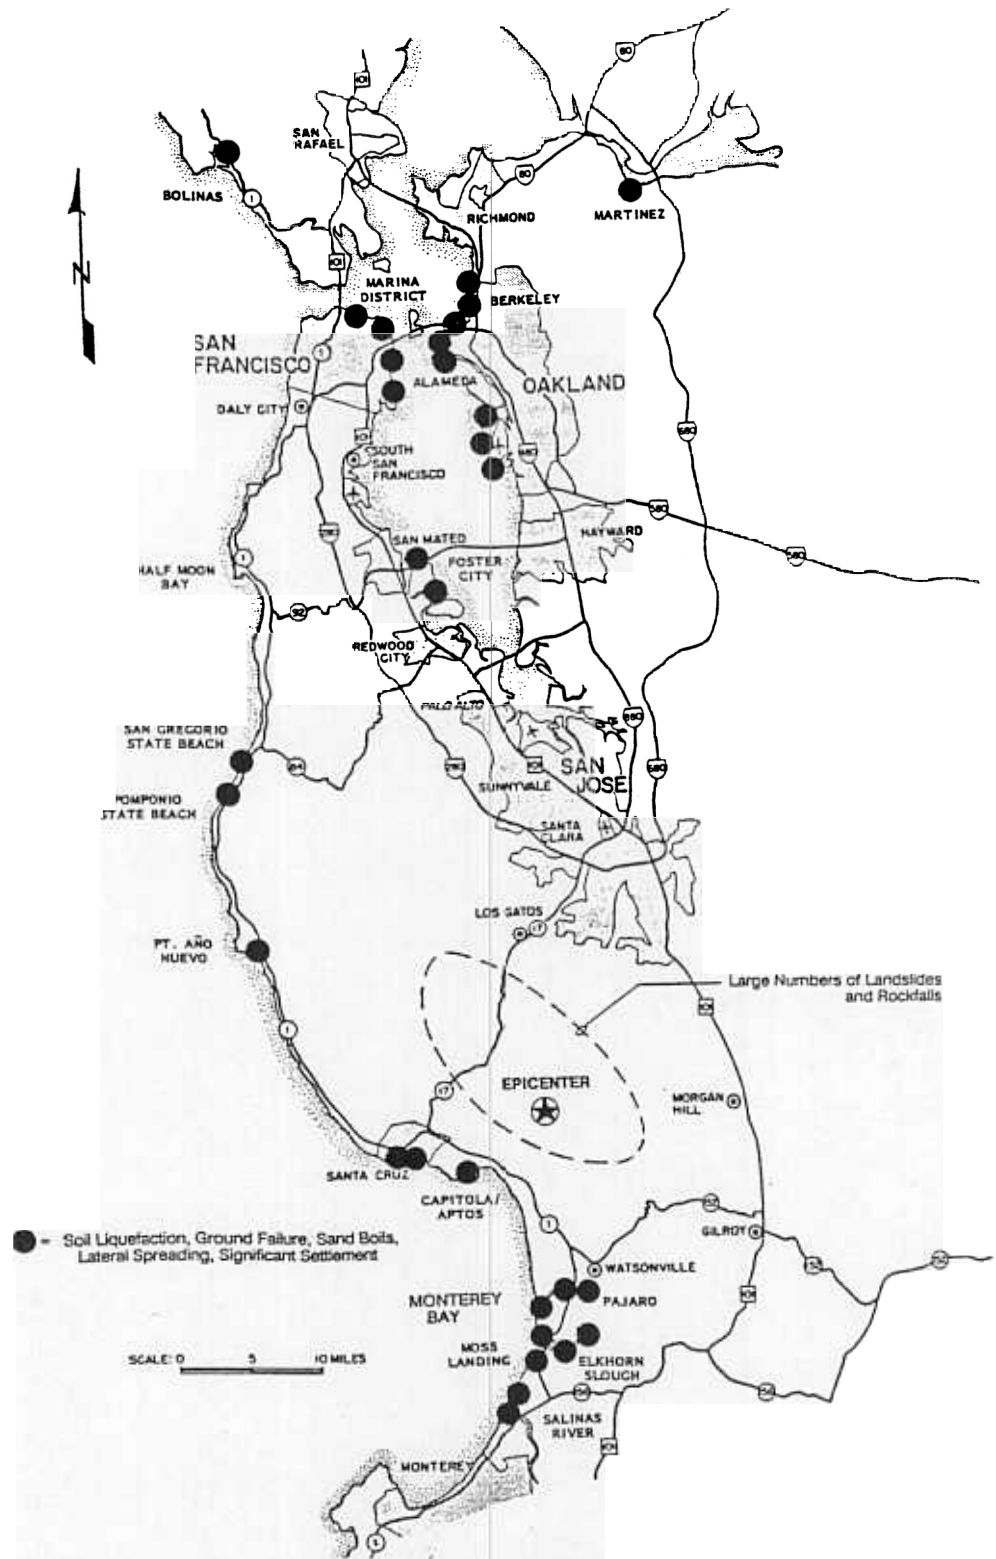
The general area affected by the earthquake and the main locations of liquefaction effects and landslides are shown on Figure 3.1. Figure 3.2 shows four areas within San Francisco for which there is historical evidence of soil liquefaction and large ground deformations during the 1906 earthquake. Photographs of typical liquefaction effects from this earthquake are shown in Figures 3.3 and 3.4. The observed geotechnical effects and their general locations are summarized by county in Table 3.1 (see page 27).

Figure 3.1 Map of affected region (Courtesy R. B. Seed)

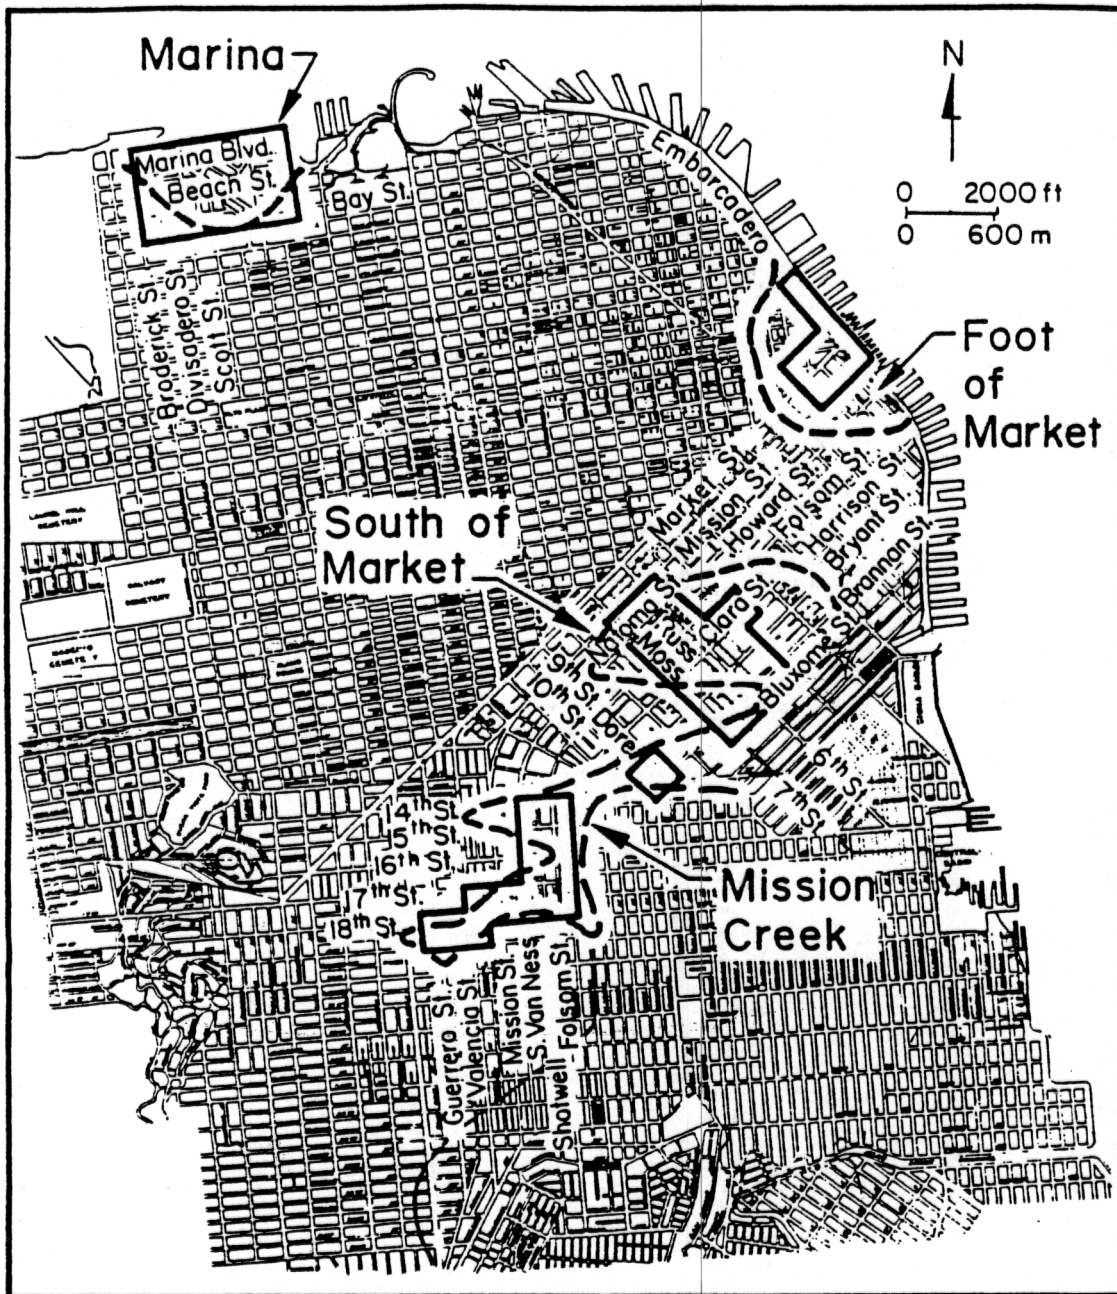
Figure 3.2 Plan view of San Francisco showing zones of 1906 soil liquefaction and inspection after the 1989 earthquake
